# Manhole Inspection Summary

Manhole # S13II\_010MH

Insp Date: **2/23/09 4:06 PM**

**Location** Address: **2801 DUKELAND ST**

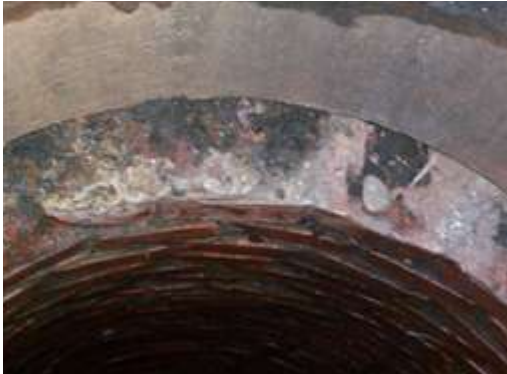
Defect 2

Offset: **3** (in.)

FRAME OFFSET

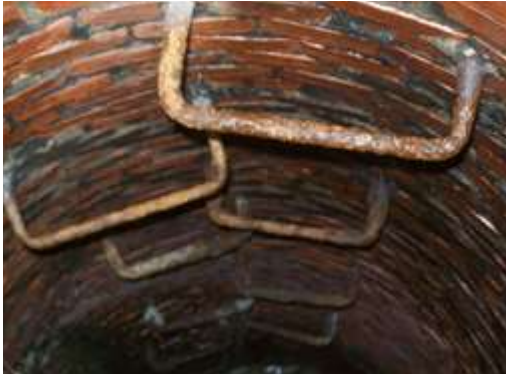
Defect 1

Count: **10** Missing: **0** ☒ **Corroded**

CORRODED STEPS

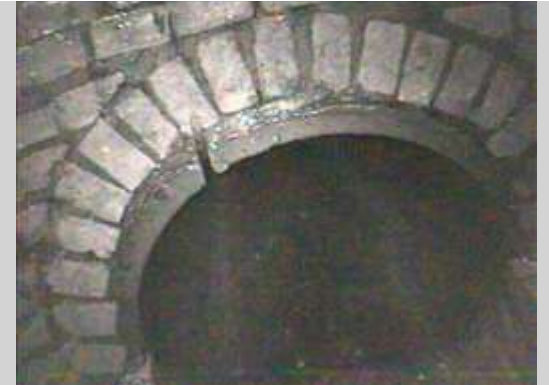
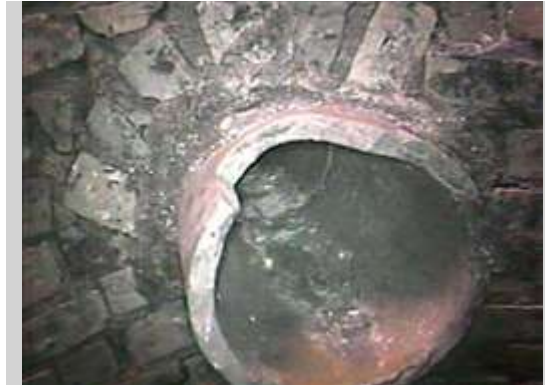
12 O'Clock Outflow

corroded steps

Pipe Height: **21.6** (in.) Rod and Bar  
Pipe Material: **Clay** ☐ Pipe Lined  
Invert Depth: **17.03** (ft.) Flow Characteristics: **Slow**  
Deposits: ☒ None ☐ Mud ☐ Sludge ☐ Debris ☐ Grease  
Silt Depth: (in.) Deposits Extent:  
Infiltration: **None** Pipe Seal Cond: **Broken**

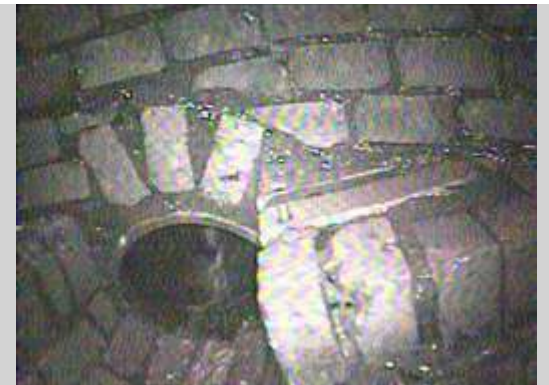
3 O'Clock Inflow

Pipe Height: **6** (in.) Rod and Bar  
Pipe Material: **Clay** ☐ Pipe Lined  
Invert Depth: **7.20** (ft.) Flow Characteristics: **Slow**  
Deposits: ☒ None ☐ Mud ☐ Sludge ☐ Debris ☐ Grease  
Silt Depth: (in.) Deposits Extent:  
Infiltration: **None** Pipe Seal Cond: **Broken**

Drop: **Outside Direct**  
Angled: Reading: (ft.)  
Inv Depth: **16.97** (ft.)  
Drop Condition: **Open**

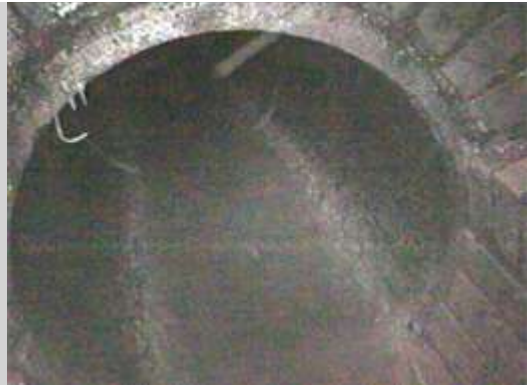
6 O'Clock Inflow

Pipe Height: **19.2** (in.) Rod and Bar

Infiltration: **None** Pipe Seal Cond: **Sound**

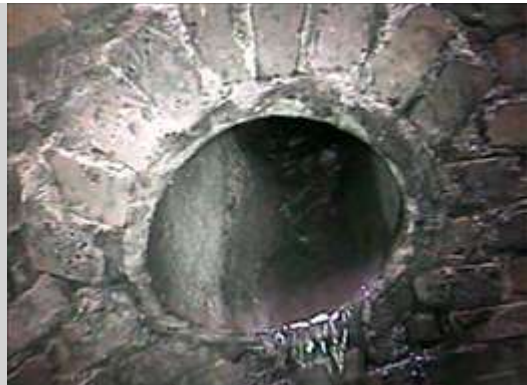
9 O'Clock Inflow

Pipe Height: **8.4** (in.) Rod and Bar

Infiltration: **None** Pipe Seal Cond: **Sound**

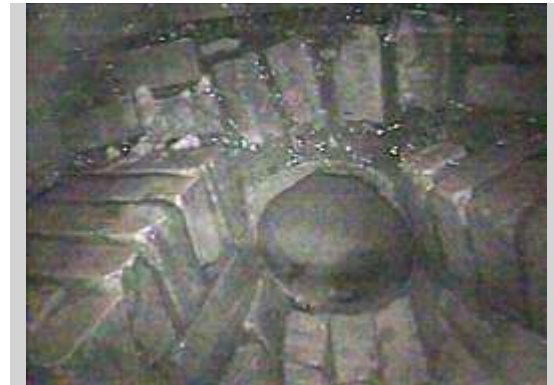
Drop In @ 9 O'Clock

Drop: **Outside Direct**

Inv Depth: **16.94** (ft.)

Drop Condition: **Open**
